**Flood Control Project Maintenance
Levee Inspections**

Fall 2018 Levee Maintenance Deficiency Summary Report

San Joaquin River Basin

**Flood Control Project Maintenance
Levee Inspections****LMA District Cover Sheet****Fall 2018 Levee Inspection Results****Reclamation District No. 0524 Middle Roberts Island**

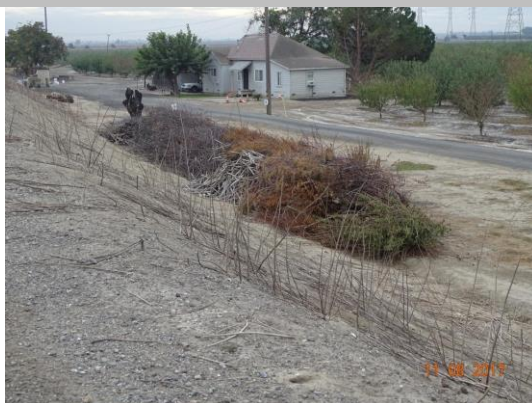
Photo 1 of 2 : FA_2018_RD0524_107_175_20180906_00229.jpg

LM Start	5.70	Rating **	U	Issue No.	175
LM End	5.70	Issue Type +	En	Location *	LS
Category	Earthen Levee			GPS Latitude/Longitude	
				Start	End
Item	Encroachments			37.876417 °	37.876417 °
				-121.332505 °	-121.332505 °
DWR ID	DWR_RD0524_01_s_2017_175				
Comment Code					
PR : Prunings					
Inspector Comment

Looking southwest at the landside slope.

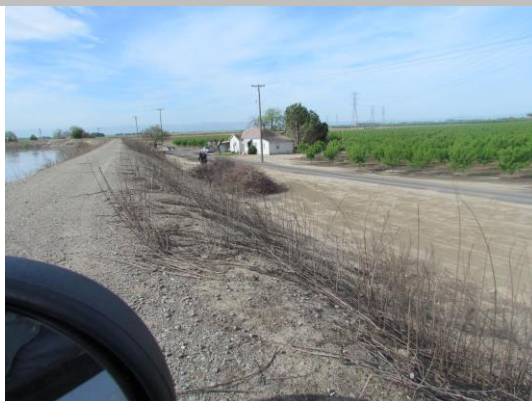
Photo 2 of 2 : FA_2018_RD0524_107_175_20180906_00230.jpg

Looking south at large pruning pile at landward toe.

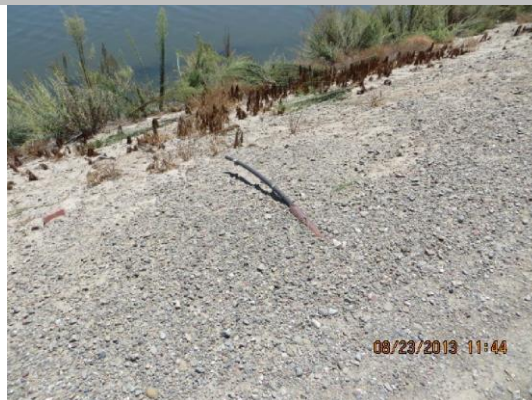
Photo 2 of 2 : UCIP_FA_2018_18364_30760.jpg

Steel conduit and electrical conduit visible on the WS shoulder.

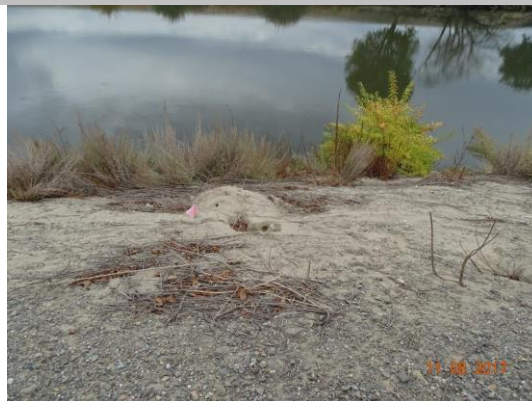
Photo 1 of 1 : FA_2018_RD0524_107_271_20180906_00358.jpg

LM Start	5.76	Rating **	A/W	Issue No.	271
LM End	5.76	Issue Type +	Ma	Location *	WS
Category	Earthen Levee			GPS Latitude/Longitude	
				Start	End
Item	Animal Control			37.875631 °	37.875631 °
				-121.332907 °	-121.332907 °
DWR ID	DWR_RD0524_01_f _ 2017_271				
Comment Code					
A3 : No rodents visible, but rodent burrows visible; need to backfill and compact or grout burrows.					
Inspector Comment

Looking east at the waterside slope.

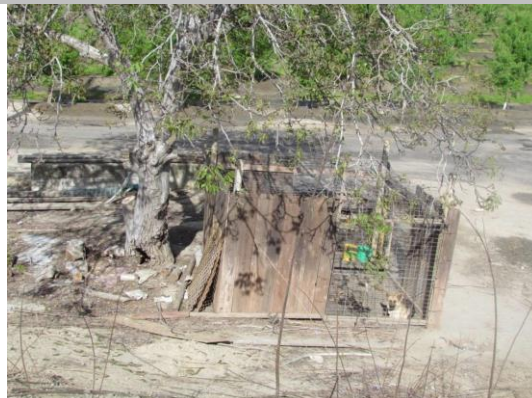
Photo 1 of 1 : FA_2018_RD0524_107_181_20180906_00239.jpg

LM Start	5.77	Rating **	U	Issue No.	181
LM End	5.77	Issue Type +	En	Location *	LS
Category	Earthen Levee			GPS Latitude/Longitude	
				Start	End
Item	Encroachments			37.875545 °	37.875545 °
				-121.332952 °	-121.332952 °
DWR ID	DWR_RD0524_01_s_2017_181				
Comment Code					
BU : Building					
Inspector Comment					
Animal kennels at landside toe.

Looking west at animal pen at landward toe.

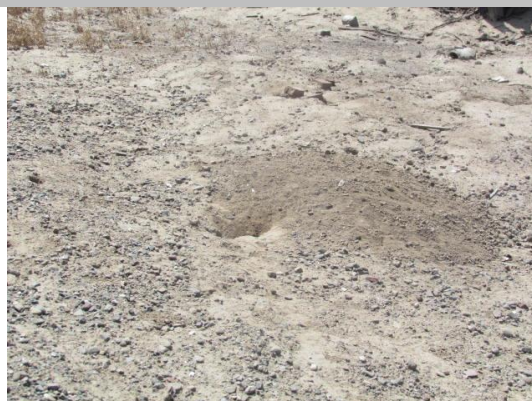
Photo 1 of 2 : FA_2018_RD0524_107_197_20180906_00259.jpg

LM Start	5.77	Rating **	A/W	Issue No.	197
LM End	5.79	Issue Type +	Ma	Location *	LS
Category	Earthen Levee			GPS Latitude/Longitude	
				Start	End
Item	Animal Control			37.875545 °	37.875310 °
				-121.332952 °	-121.333065 °
DWR ID	DWR_RD0524_01_s_2015_197				
Comment Code					
A1 : Exterminate rodents and backfill and compact or grout burrows.					
Inspector Comment					
Several rodent holes on landside slope and levee crown. Backfilled hole but no rodent program visible.

Looking north at typical view of rodent holes on landward slope.

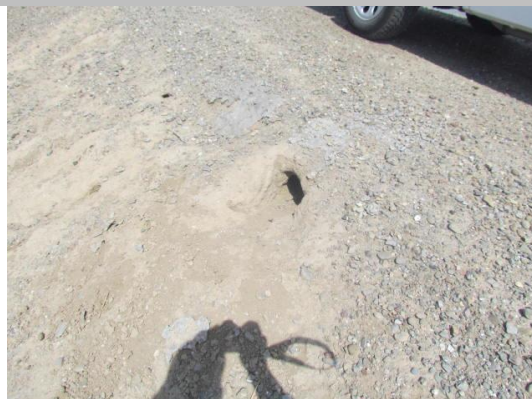
Photo 2 of 2 : FA_2018_RD0524_107_197_20180906_00260.jpg

Looking southwest at typical view of rodent hole at landward shoulder.

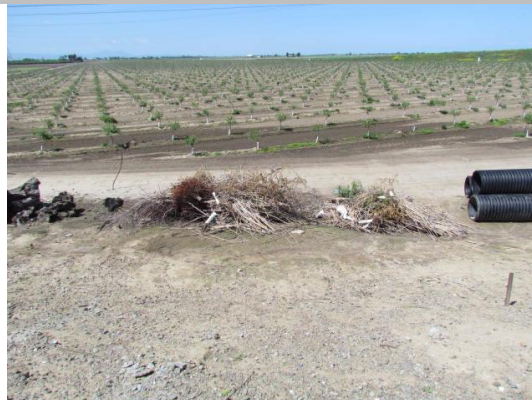
Photo 1 of 1 : FA_2018_RD0524_107_267_20180906_00356.jpg

LM Start	5.79	Rating **	A/W	Issue No.	267
LM End	5.79	Issue Type +	En	Location *	LS
Category	Earthen Levee			GPS Latitude/Longitude	
				Start	End
Item	Encroachments			37.875328 °	37.875328 °
				-121.333050 °	-121.333050 °
DWR ID	DWR_RD0524_01_s_2012_267				
Comment Code					
PR : Prunings					
Inspector Comment					
Prunings at landside toe should be burned or removed.

Looking west at prunings at landward toe.

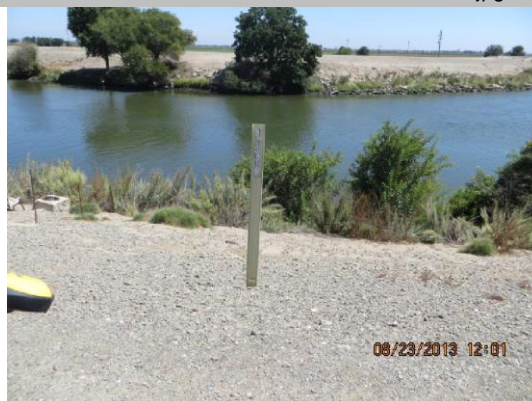
Photo 1 of 1 : UCIP_FA_2018_18705_31249.jpg

LM Start	5.82	Rating **	M	Issue No.	967
LM End	5.82	Issue Type +	En	Location *	
Category	Supplemental			GPS Latitude/Longitude	
				Start	End
Item	DWR UCIP Field Study			37.874829 °	37.874829 °
				-121.333265 °	-121.333265 °
DWR ID	20656				
Comment Code					
Inspector Comment					
FS_ID:18705 DS_ID:20656 EP_NO: N/A Repair Type: Non-Urgent Crossing Status: Indicator Found UCIP Comments: Need to verify gasline exists and if so improve signage. FIELD_STRUCT_DESC: Gas line marker sign on the waterside (WS) shoulder. FS Date: 8/23/2013

Gasline marker on WS shoulder.

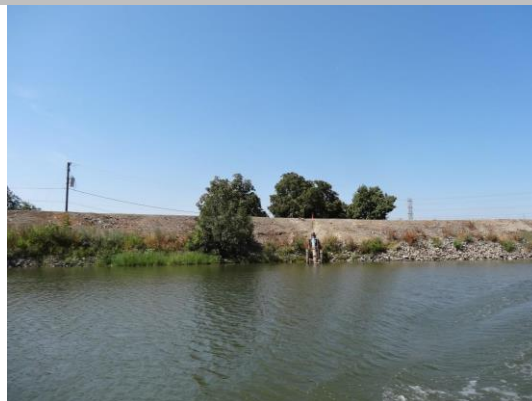
Photo 1 of 2 : FA_2018_RD0524_107_93_20180906_00157.jpg

LM Start	5.86	Rating **	U	Issue No.	93
LM End	5.86	Issue Type +	Ma	Location *	WS
Category	Supplemental			GPS Latitude/Longitude	
				Start	End
Item	DWR Erosion Survey			37.874370 °	37.874370 °
				-121.332850 °	-121.332850 °
DWR ID	RD0524U01RM46.39				
Comment Code					
Inspector Comment					
09/13/2017: No significant change observed.					
07/25/2016: No significant change observed.					
06/24/2015: No significant change observed.					
06/19/2014: No significant change observed.					
08/13/2013: No significant change observed.					
08/07/2012: The erosion is near a water-intake structure. Pipe leakage likely caused the erosion. [2017 Site ID:RD0524U01RM46.39]

Front view of the site.

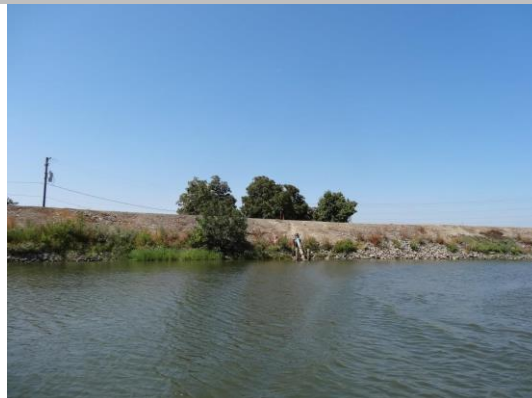
Photo 2 of 2 : FA_2018_RD0524_107_93_20180906_00158.jpg

View of the erosion.

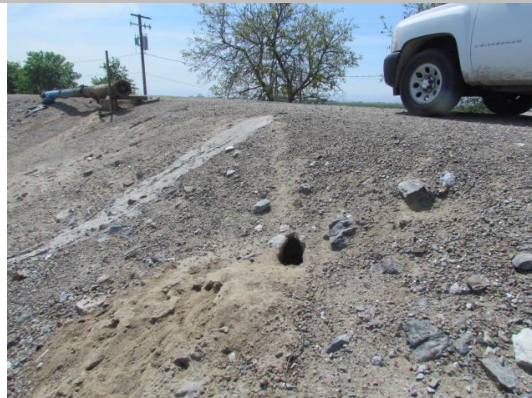
Photo 1 of 2 : FA_2018_RD0524_107_75_20180906_00131.jpg

LM Start	5.86	Rating **	M	Issue No.	75
LM End	5.88	Issue Type +	Ma	Location *	WS
Category	Earthen Levee			GPS Latitude/Longitude	
				Start	End
Item	Animal Control			37.874240 °	37.874002 °
				-121.333187 °	-121.333027 °
DWR ID	DWR_RD0524_01_s_2012_75				
Comment Code					
A1 : Exterminate rodents and backfill and compact or grout burrows.					
Inspector Comment					
District has grouted rodent holes, but other rodent holes have appeared. Active rodents in area.

Looking southwest at typical rodent holes on waterward slope.

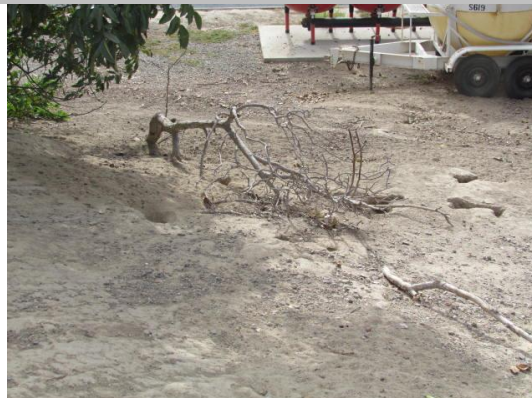
Photo 2 of 2 : FA_2018_RD0524_107_75_20180906_00132.jpg

Looking typical view of several rodent holes on landward slope and toe.

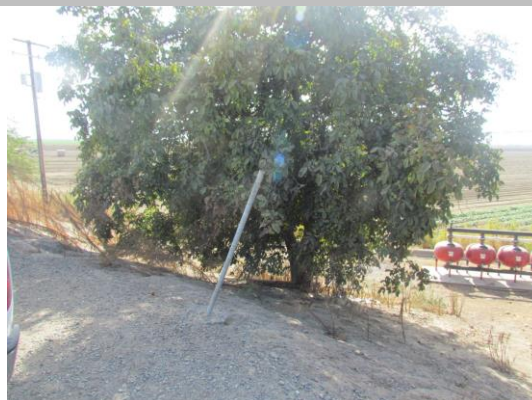
Photo 1 of 1 : FA_2018_RD0524_107_98_20180906_00164.jpg

LM Start	5.87	Rating **	M	Issue No.	98
LM End	5.87	Issue Type +	Ma	Location *	LS
Category	Earthen Levee			GPS Latitude/Longitude	
				Start	End
Item	Trim / Thin Trees			37.874085 °	37.874085 °
				-121.333154 °	-121.333154 °
DWR ID	DWR_RD0524_01_s_2012_98				
Comment Code					
T1 : Trim trees to at least five feet above ground level.					
Inspector Comment					
Untrimmed walnut tree on landside slope.

Looking west at walnut tree on landward slope.

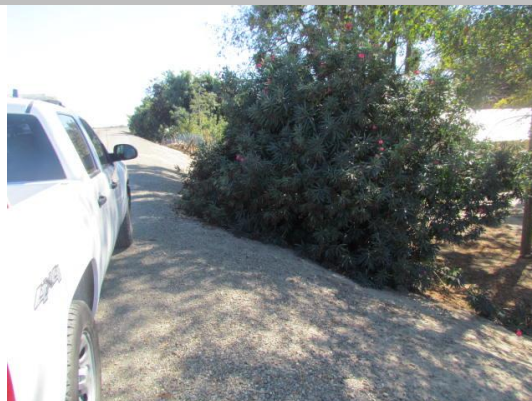
Photo 1 of 1 : FA_2018_RD0524_107_200_20180906_00265.jpg

LM Start	5.92	Rating **	U	Issue No.	200
LM End	5.92	Issue Type +	En	Location *	LS
Category	Earthen Levee			GPS Latitude/Longitude	
				Start	End
Item	Vegetation			37.873623 °	37.873623 °
				-121.332585 °	-121.332585 °
DWR ID	DWR_RD0524_01_f_2015_200				
Comment Code					
V6 : Landscaping					
Inspector Comment					
Oleander bush on landside slope.

Looking south at oleander on landward slope fall 2015.

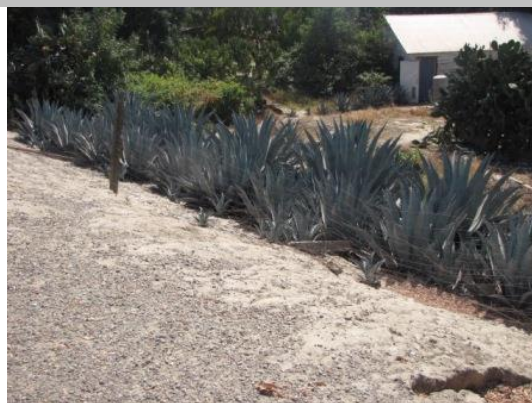
Photo 1 of 1 : FA_2018_RD0524_107_88_20180906_00151.jpg

LM Start	5.94	Rating **	U	Issue No.	88
LM End	5.95	Issue Type +	En	Location *	LS
Category	Earthen Levee			GPS Latitude/Longitude	
				Start	End
Item	Vegetation			37.873543 °	37.873445 °
				-121.332308 °	-121.332127 °
DWR ID	DWR_RD0524_01_s_2012_88				
Comment Code					
V6 : Landscaping					
Inspector Comment					
Cactus and Century plants on landside slope and toe.

Looking southeast at fence and cactus on landside slope and toe.

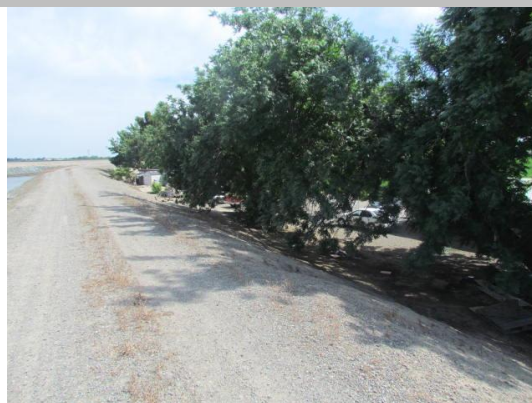
Photo 1 of 1 : FA_2018_RD0524_107_120_20180906_00187.jpg

LM Start	5.96	Rating **	U	Issue No.	120
LM End	5.96	Issue Type +	En	Location *	LS
Category	Earthen Levee			GPS Latitude/Longitude	
				Start	End
Item	Vegetation			37.873347 °	37.873347 °
				-121.332028 °	-121.332028 °
DWR ID	DWR_RD0524_01_s_2012_120				
Comment Code					
V6 : Landscaping					
Inspector Comment					
Trim trees up 5-feet off ground for visibility.

Looking south at untrimmed trees on landward slope and toe.

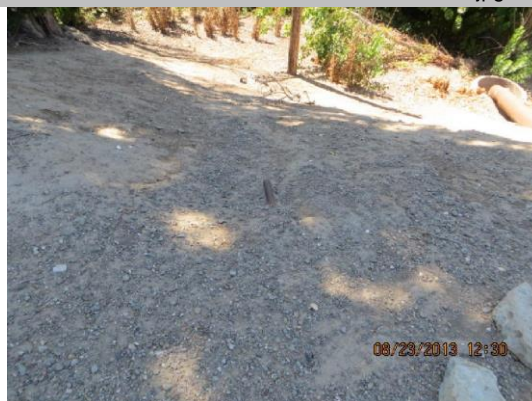
Photo 1 of 2 : UCIP_FA_2018_22073_37670.jpg

LM Start	6.15	Rating **	M	Issue No.	970
LM End	6.15	Issue Type +	En	Location *	
Category	Supplemental			GPS Latitude/Longitude	
				Start	End
Item	DWR UCIP Field Study			37.871118 °	37.871118 °
				-121.330137 °	-121.330137 °
DWR ID	24052				
Comment Code					
Inspector Comment					
FS_ID:22073 DS_ID:24052 EP_NO: N/A Repair Type: Non-Urgent Crossing Status: Found UCIP Comments: Abandoned and should be done so properly. FIELD_STRUCT_DESC: *ABANDONED* 1.75-inch galvanized iron electrical conduit through the levee, 1 foot below the crown. Power pole on the landside (LS) toe. FS Date: 8/23/2013

Pipe visible on LS slope.

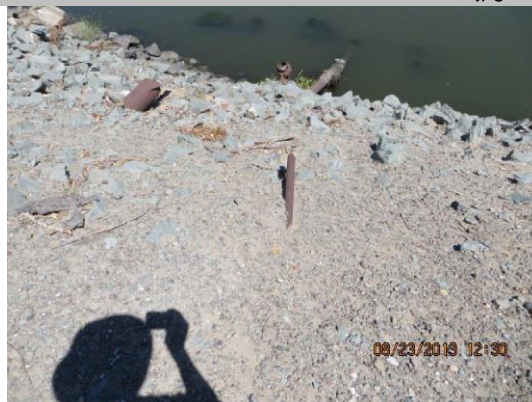
Photo 2 of 2 : UCIP_FA_2018_22073_37669.jpg

Pipe visible on WS slope.

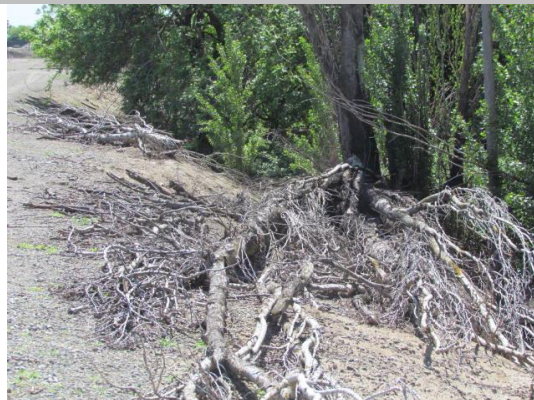
Photo 1 of 2 : FA_2018_RD0524_107_81_20180906_00141.jpg

LM Start	6.15	Rating **	M	Issue No.	81
LM End	6.15	Issue Type +	Ma	Location *	LS
Category	Earthen Levee			GPS Latitude/Longitude	
				Start	End
Item	Encroachments			37.871097°	37.871097°
				-121.330100°	-121.330100°
DWR ID	DWR_RD0524_01_s_2015_81				
Comment Code					
TR : Tree or limb					
Inspector Comment					
Fallen tree branches and limbs on landside slope.

Looking west at tree branches and limbs left on landward shoulder and slope. (Spring 2016)

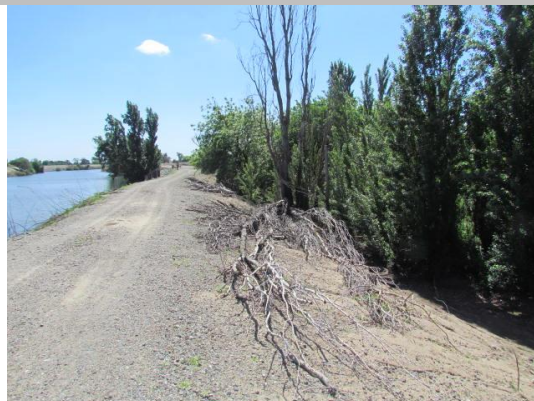
Photo 2 of 2 : FA_2018_RD0524_107_81_20180906_00142.jpg

LM Start	6.15	Rating **	M	Issue No.	81 (cont)
LM End	6.15	Issue Type +	Ma	Location *	LS

Looking south at tree branches and limbs left on landward shoulder and slope. (Spring 2016)

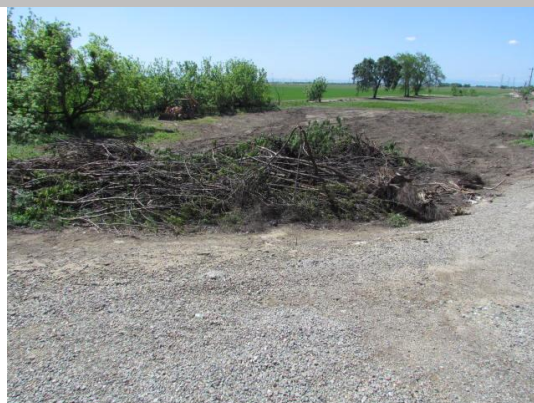
Photo 1 of 1 : FA_2018_RD0524_107_86_20180906_00150.jpg

LM Start	6.20	Rating **	U	Issue No.	86
LM End	6.20	Issue Type +	En	Location *	LS
Category	Earthen Levee			GPS Latitude/Longitude	
				Start	End
Item	Encroachments			37.870388 °	37.870388 °
				-121.329840 °	-121.329840 °
DWR ID	DWR_RD0524_01_s_2016_86				
Comment Code					
PR : Prunings					
Inspector Comment					
Large pruning pile left at landside toe.

Looking west at prunings at landward toe and berm.
